EXHIBIT

Fwd: Recon converter issues

Fwd: FW: Cookeville Quality Issue: FM89L

Fwd: 159935 Dynotec converter issues

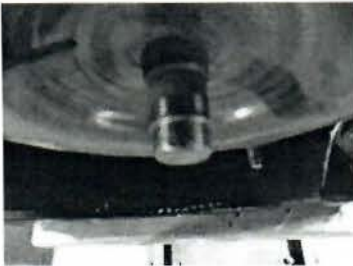
FM68HD as returned.JPG
1456K

FM68HD as returned: This is the RECON FM68HD as returned by the customer. The displaced metal has been dressed down by the customer, but it still would not install properly in the crank shaft. Basically it would not slip deep enough into the crank shaft to allow the flex plate to get bolted to the converter.

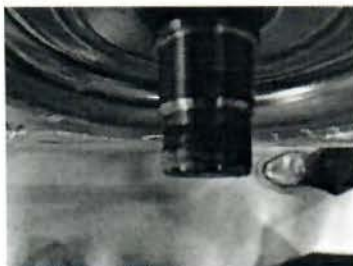
FM68HD ford unit.JPG
1266K

FM68HD Ford unit: Final photo shows a stock Ford converter core that has a properly machined crankshaft pilot. It would appear that the RECON converter pilot is not machined properly when compared to an OEM pilot.

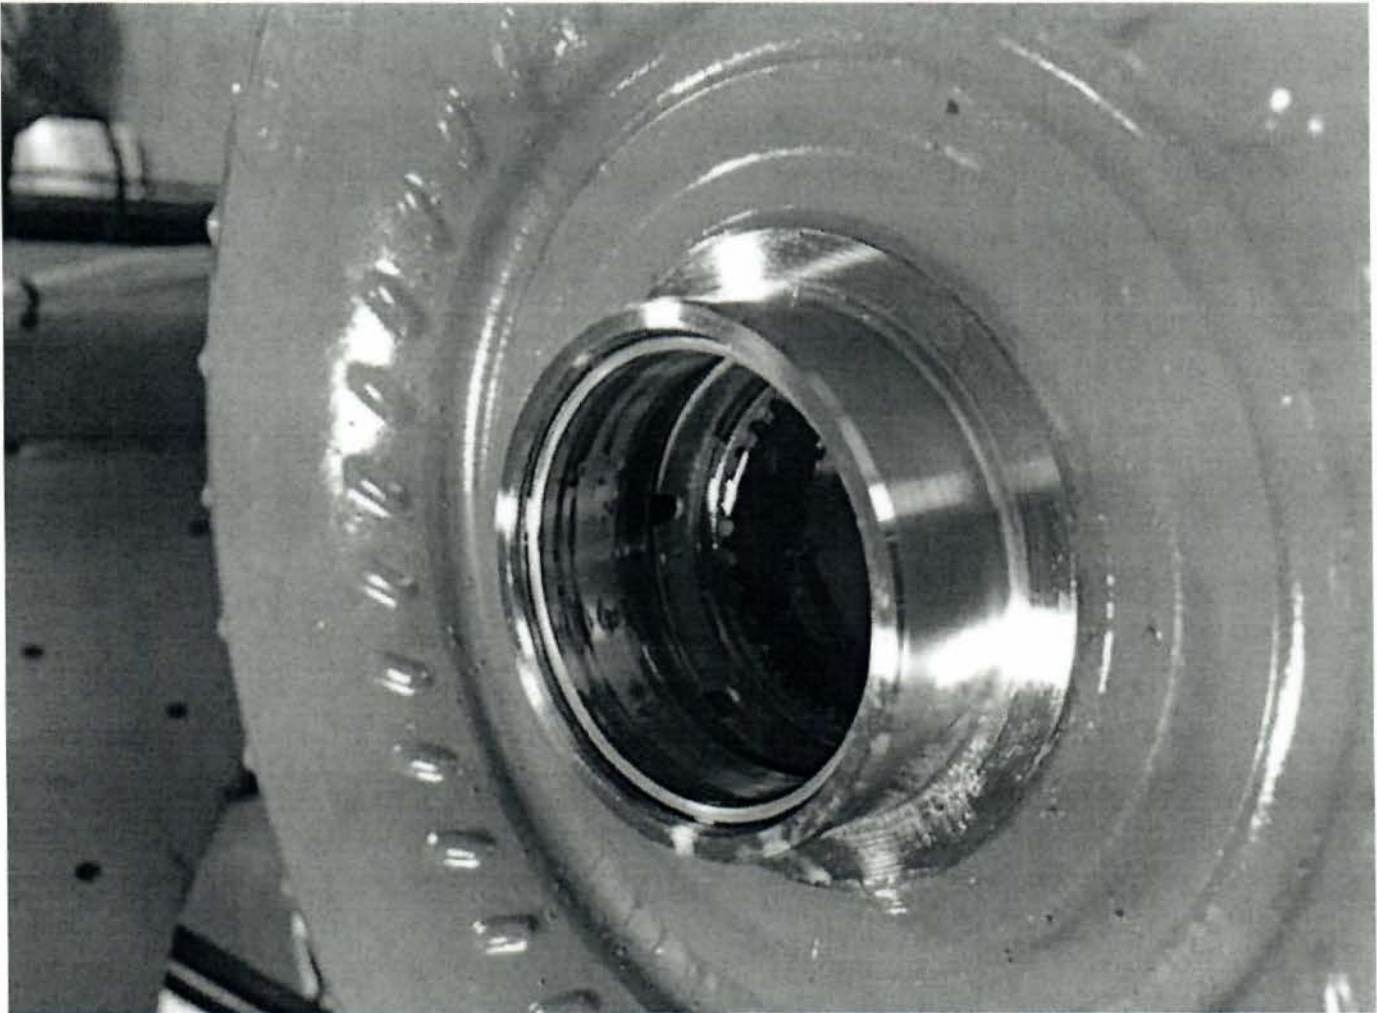
Here is the Dynotec issue with the FM89L. According to Dave Recon used a "unfinished bushing" for this item and did not have the same fit issues we are experiencing now.

3 of them (build date 6/12/15) that have oversize bushings and cannot be installed

Attached is a photo of one of these FM89L converters with an oversize bushing from last week that was barely able to be installed only to be killed by initial operation on the Dyno.

We have corrected product available to ship. Please see retrieval notice from July. Clearly we missed the inventory related to Dynotech.
